**CONTINENTAL PLACER INC.**

**PHASE I WATER SUPPLY INVESTIGATION**  
Deansboro Water District  
Towns of Marshall and Kirkland  
Oneida County, New York

February 2005

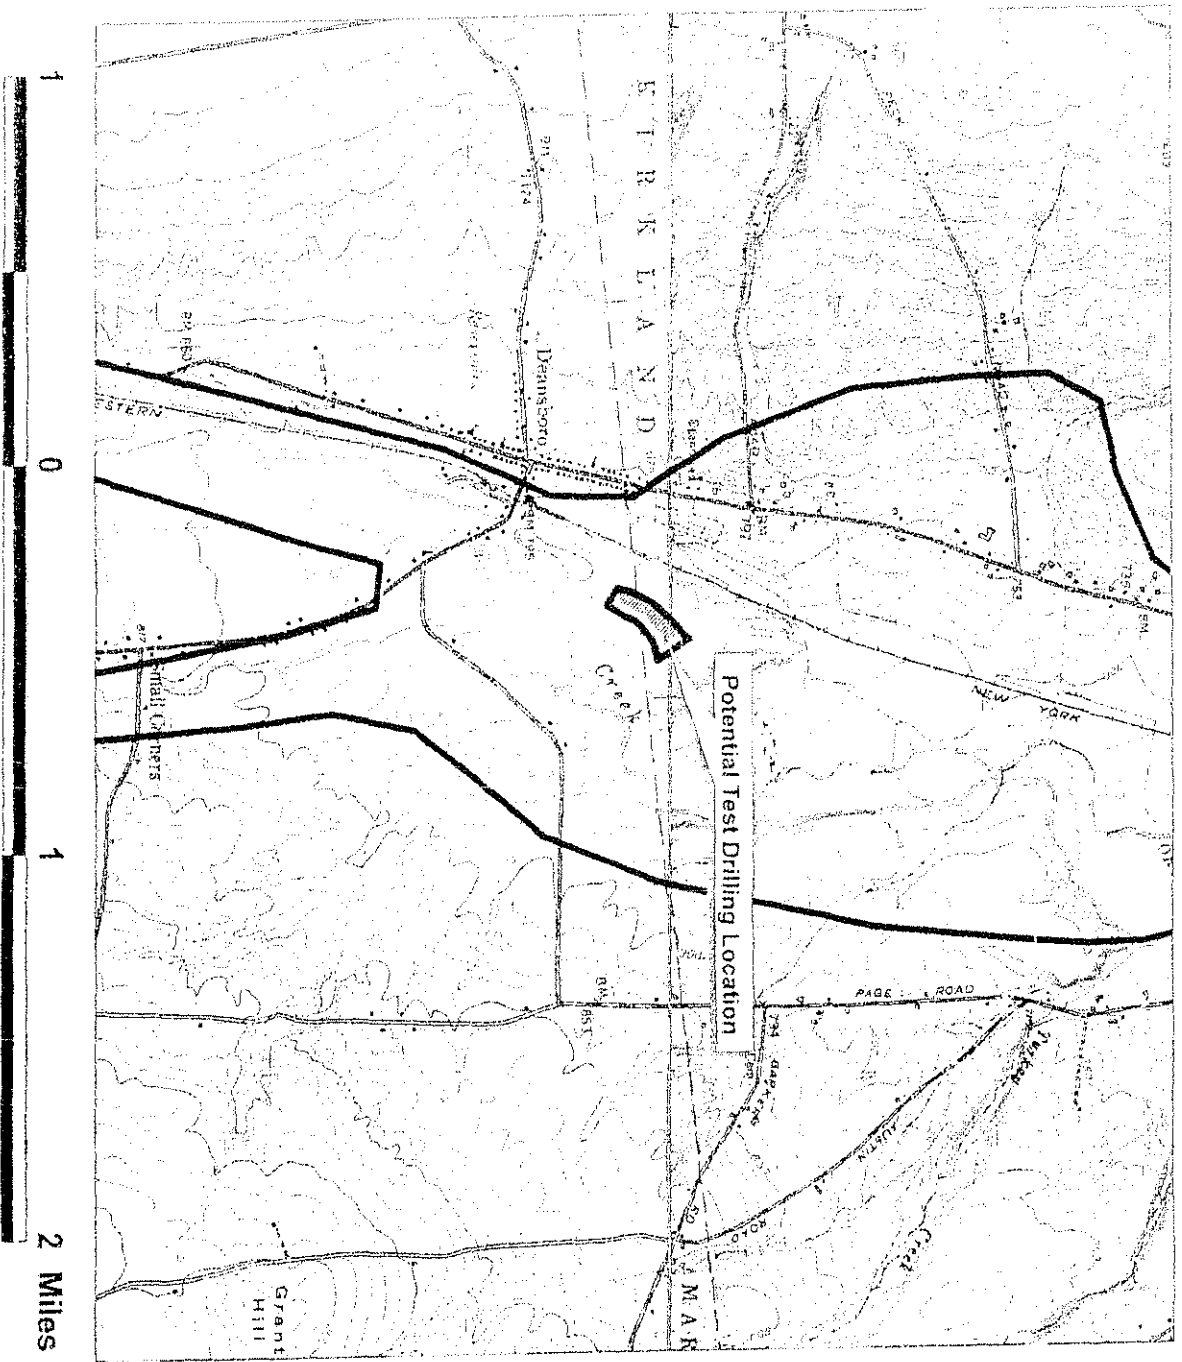
# Figure 1

□ Sand and Gravel Aquifer

In light of recent supply shortages the Deansboro Water District has decided to investigate developing an additional supply of water. Based upon a review of the hydrogeology of the area and the availability and access of land in the vicinity of the existing water system, the District has elected to pursue development of a well supply on a small portion of a 104.6 acre tract of land that is owned by the Town of Marshall. This property is situated adjacent to the Oriskany Creek in an outwash sand and gravel aquifer that has been mapped by the United States Geological Survey as capable of yielding more than 100 gallons per minute (gpm) (Figure 1).
